17. Heritage Management Issues of the Shore Temple, Mamallapuram, and the Airavateswara Temple, Darasuram: A Case Study

A.M.V. Subramanyam and S. Vetriselvi

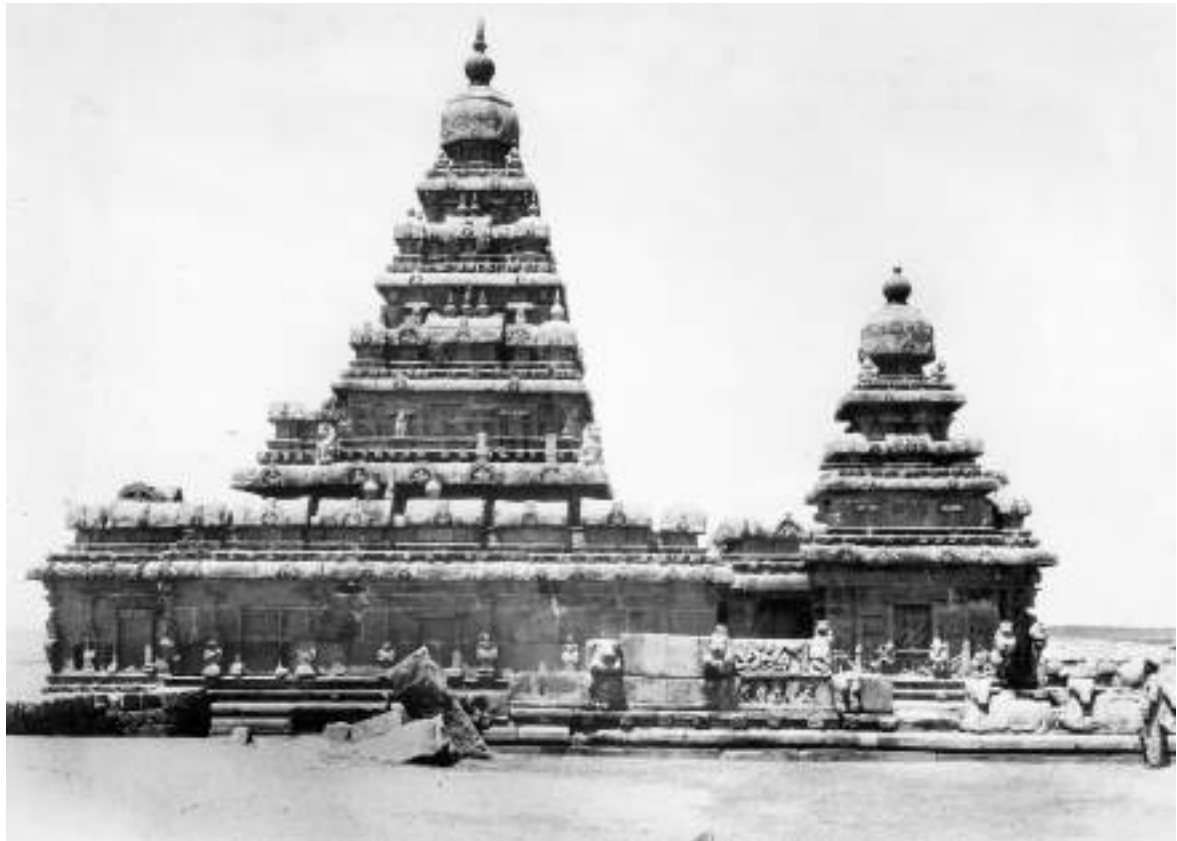
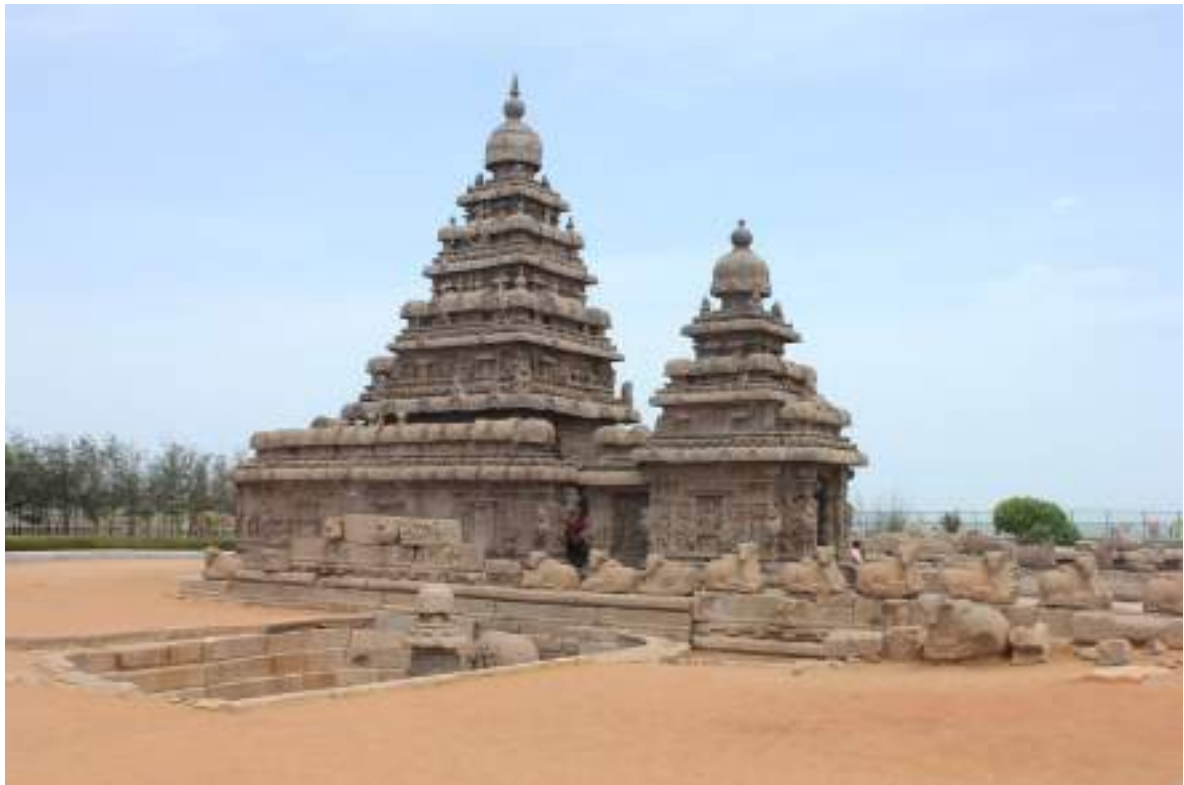
Rea made a remarkable contribution to the conservation of monuments in Mamallapuram, in particular the Shore Temple. In 1905–06, the *mahadvara* of the Shore Temple was reconstructed and the see-through joints of the masonry were pressure grouted and pointed. Further in 1906–07, a further excavation of the buried structures was carried out on the western side of the Shore Temple. Rea provided approach pathways to the monuments (Fig. 1).

*Fig. 1 a, b. Shore temple then and now at Mamallapuram
(Source : ASI)*

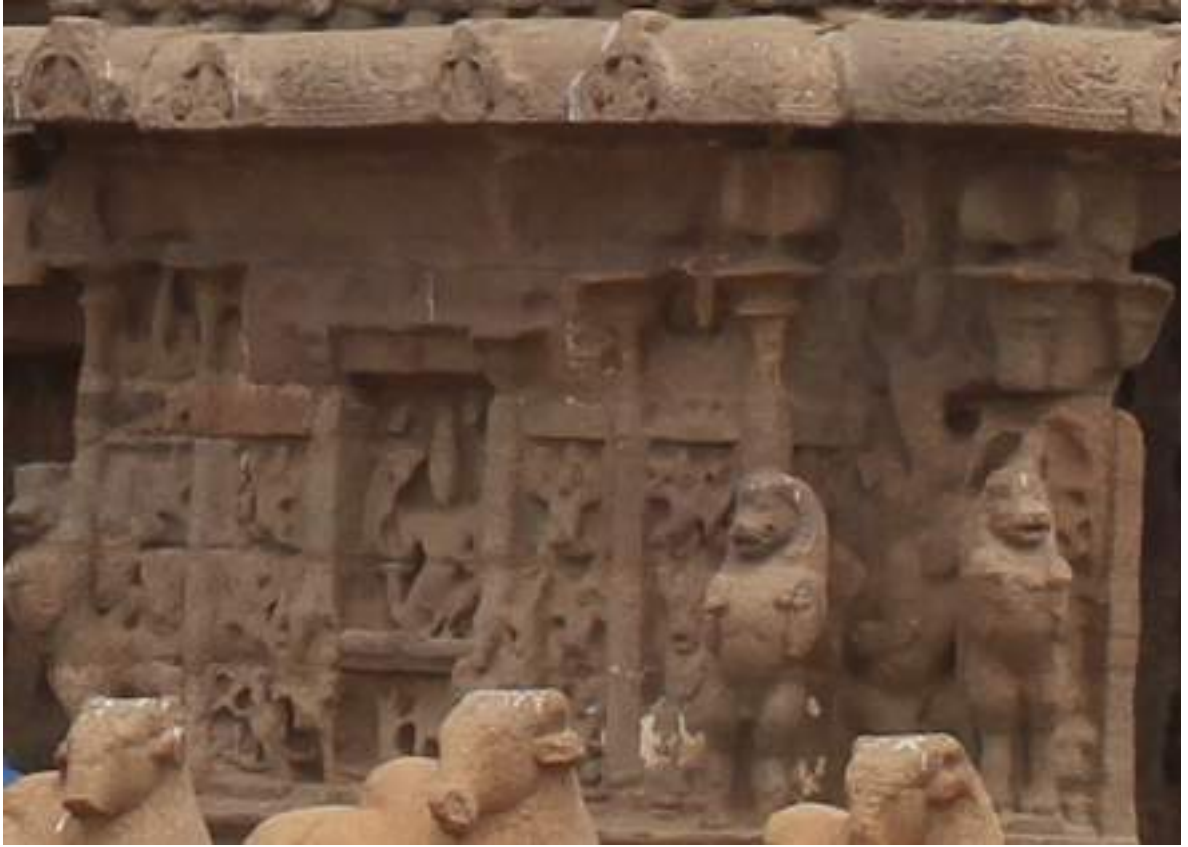
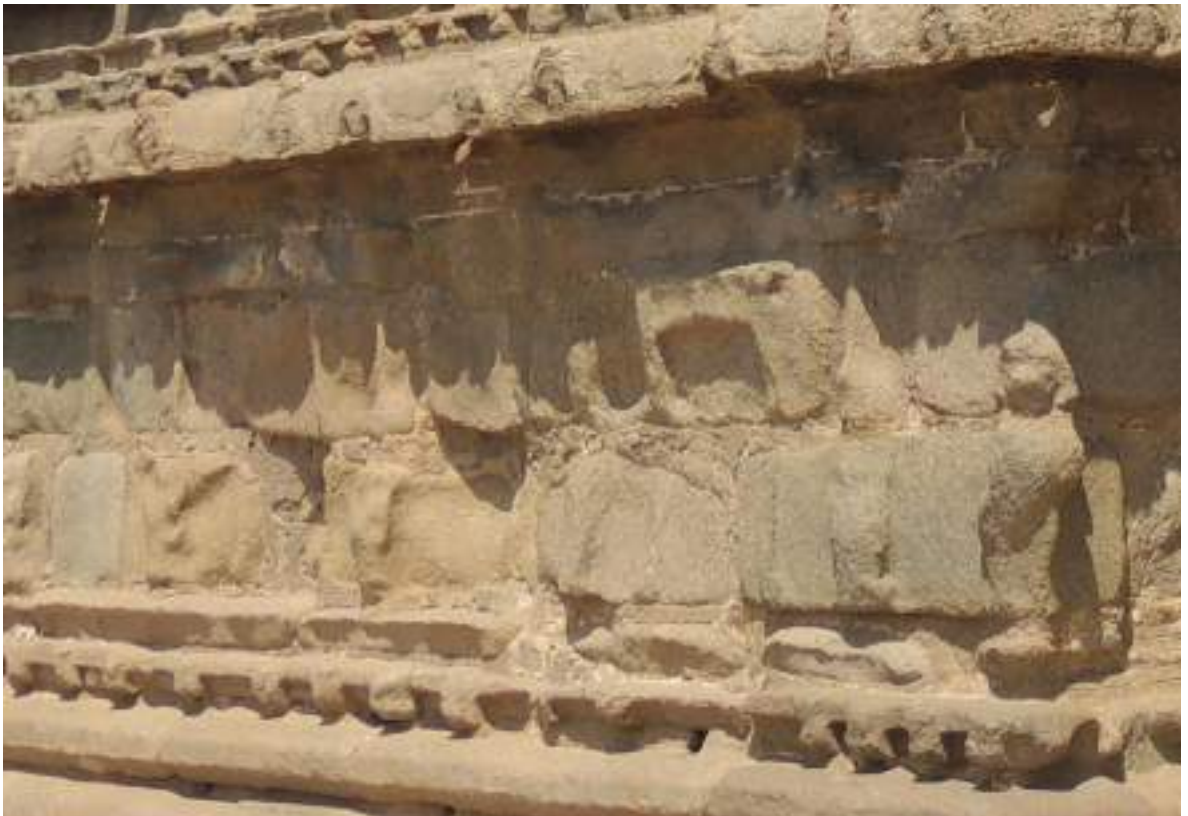
Since the rock-cut cave temples and *rathas* are part of the natural formation, there are no structural problems as such. The stone used for construction of Shore Temple is identified as leptinite (Srinivasan 1983: 56), porphyritic in texture with indistinct to well-developed foliation. The chief mineral constituents are quartz, feldspar and biotite with small amounts of accessory minerals such as magnetite apatite, garnet, sphene and zircon. However, granite was used only for the *pattika* moulding of the *adhishtana* with a specific purpose of serving as a damp roof course besides taking the load and its even distribution on the plinth. The monument did not have much structural disturbance owing to the solid foundation over the bedrock. The lashing waves and direct contact with the saline wind and also due to capillary action, the soluble salts from atmosphere and the ground are being deposited continuously on the surface of the stones. The accompanying pressure, and heat and cold at alternate intervals in course of a continuous dissolution and re-crystallisation of salt cause stress, leading to the exfoliation of the upper surface, resulting in a fragile, porous and even powdery over matrix. As a result of this dual action the features of the sculptures and other ornamentations face a higher degree of erosion. Another problem is the accumulation of drift-sand all around the monument (Narasimhaiah 1995).

Even though the periodical chemical treatment is being provided like paper pulp treatment to the surfaces, due to salt crystallisation action, the effect of erosion is so high that in ranges from few centimetre to 20 centimetre, thereby reducing the structure to critical balance at few locations. At most of the places, sculptures have been eroded to the base level, making it difficult to recognise the original features (Fig. 2).

Fig. 2 a, b. Eroded sculptures at Mamallapuram (Source : ASI)

Recently, the ASI, Chennai Circle, Chennai, made a trail patch in the south-eastern corner of *adhishtana* to counter the deterioration by applying the superficial layer of lime plaster with suitable fine aggregates where the loss of surfaces is around 3 cm. Where the loss of surface is beyond 10 cm, the appropriate sized stone blocks have been fixed for which, if required stainless steel pins and mesh were used.

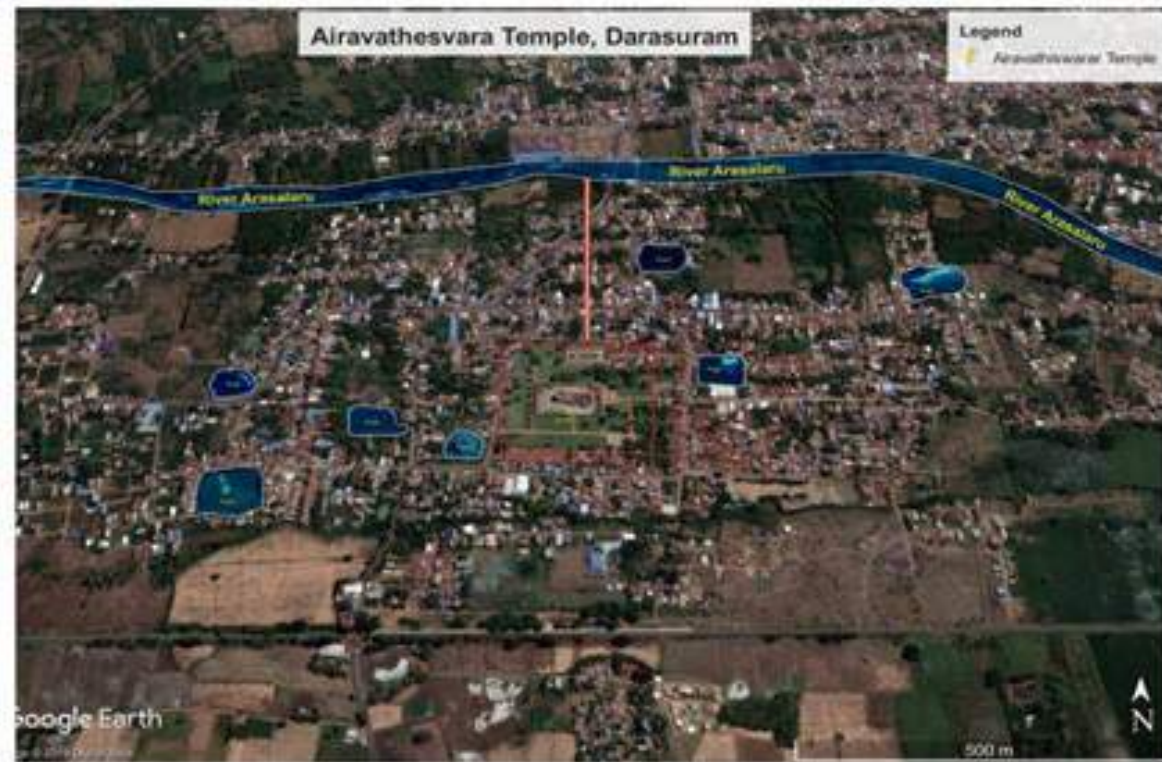
Fig. 6. Ponds around Airavathesvara Temple (Source : Google Map)

Geographically, the temple is located between the two rivers Arasalaru and Tirumalai Rayarpattinam river, which are the tributaries of river Kaveri and also the monument is surrounded by several ponds (Fig.6). Hence, water logging is the focal issue in this monument, as the monument is more than 1.5 metre lower than the present surface level. The temple is getting affected by capillary action, due to which water penetrates into the walls of the temple. Though the temple is built out of granite, it damages the stone structure, causing stone flaking, especially as observed in the *adhishtana* (foundation) portions sometimes. To investigate the problem, proper conservation measures are being taken from time to time.

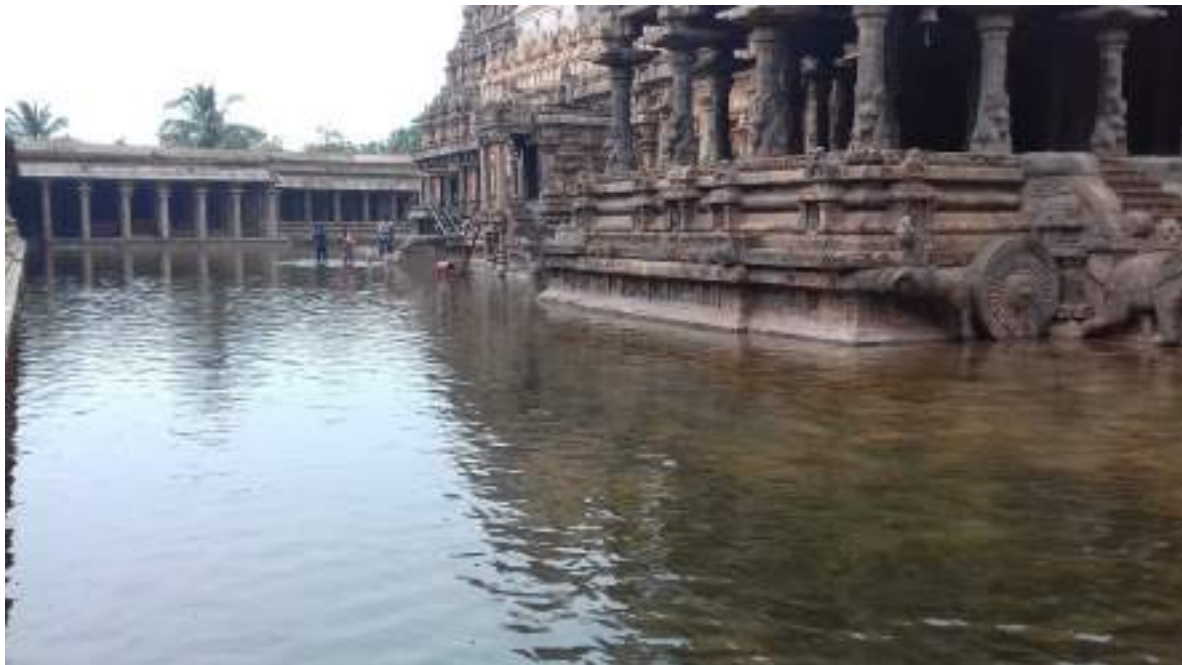
*Fig.7 Stagnation of rain Water, Airavateswara Temple, Darasuram
(Source : ASI)*

The management of cultural heritage is often related to surface and groundwater management. De-watering is one of the greatest concerns for those managing waterlogged archaeological monuments and sites, as well as a great danger for foundations of above-ground monuments. The temple is 1.5 metre below the present surface level, and rain water stagnates inside the temple complex (Fig. 7). A canal was laid from the temple to nearby pond to drain the water. However, the problem is not solved as the mean sea level (MSL) of the water level in the pond is higher than that of the temple. Hence, water enters the

temple through same canal from the pond. Temporarily, the stagnating rain water is drained out by pumping and also flagstone flooring has been provided around the temple to prevent accumulation of rainwater. The rapid growth of towns and cities, i.e. urbanisation, also threatens cultural heritage. The surrounding area of the Airavateswara temple has been occupied by the local people. New developments outside a specific protected area can lead to changes in groundwater level and cause serious damage to heritage buildings and archaeological deposits. Especially the water bodies around the Airavateswara temple are encroached by the people due to which the water stagnates inside the monument. Due to water stagnation, the stone flooring also gets damaged. Hence, proper conservation measures have been taken up periodically to conserve the floors.

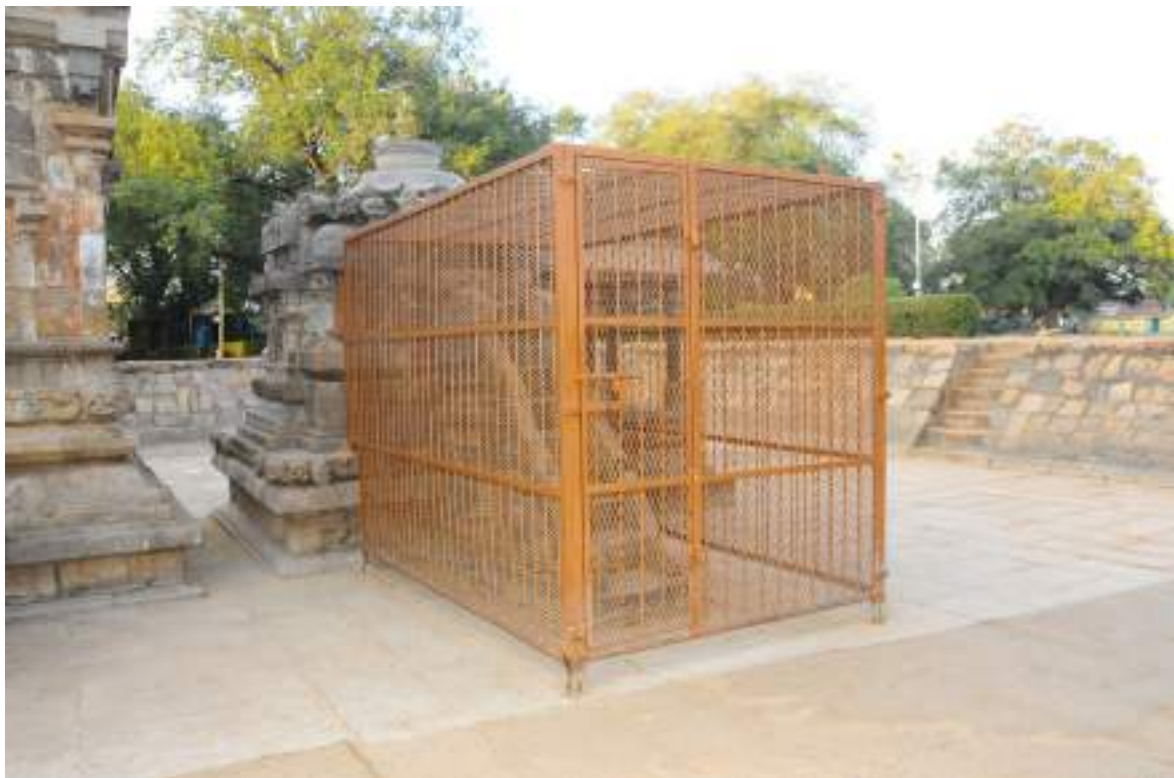
Fig. 8. Fenced stairs of bali-peeda, Darasuram (Source : ASI)

Another important feature of this temple is musical steps near Nandi mandapa. Each step emits different musical tone on a musical scale. As mentioned earlier, the temple is a living monument and so an active participation of the general public is unavoidable throughout the year. Driven by curiosity, people started beating the steps by using stones, which led to its damage. Hence, the ASI, Chennai Circle, has provided iron grill gates to the steps and kept it locked to prevent vandalism (Fig. 8).
