ALGAL GROWTH IN TEMPLES OF TAMILNADU A CASE STUDY

ABSTRACT

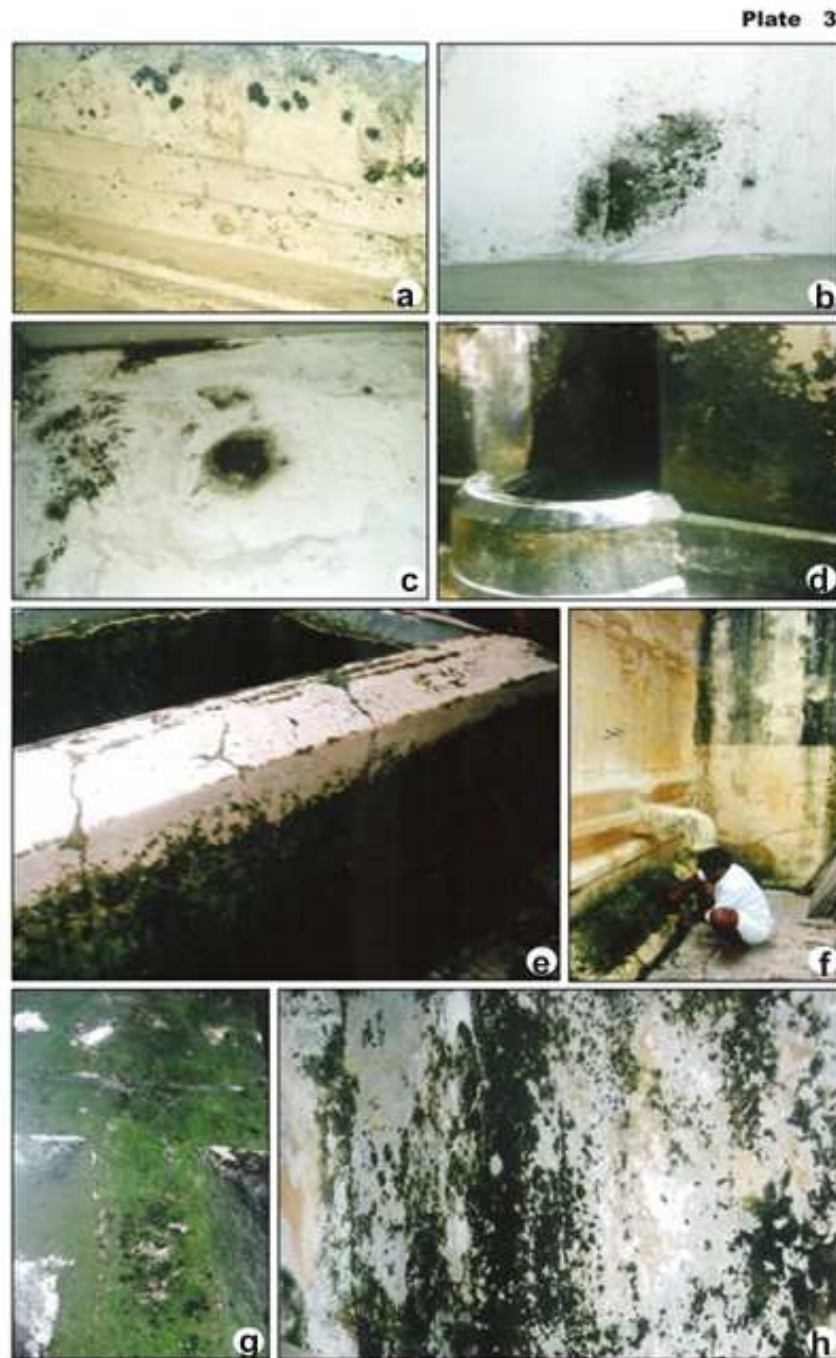
Plate 3 Rāmanātaswāmy temple, Rameswaram

a, b & c. Organisms under roof; **d.** A well and adjacent wall; **e.** A well wall; **f.** Sample collection at a shrine basement; **g.** Organisms in a Pillar; **h.** Floor near a well

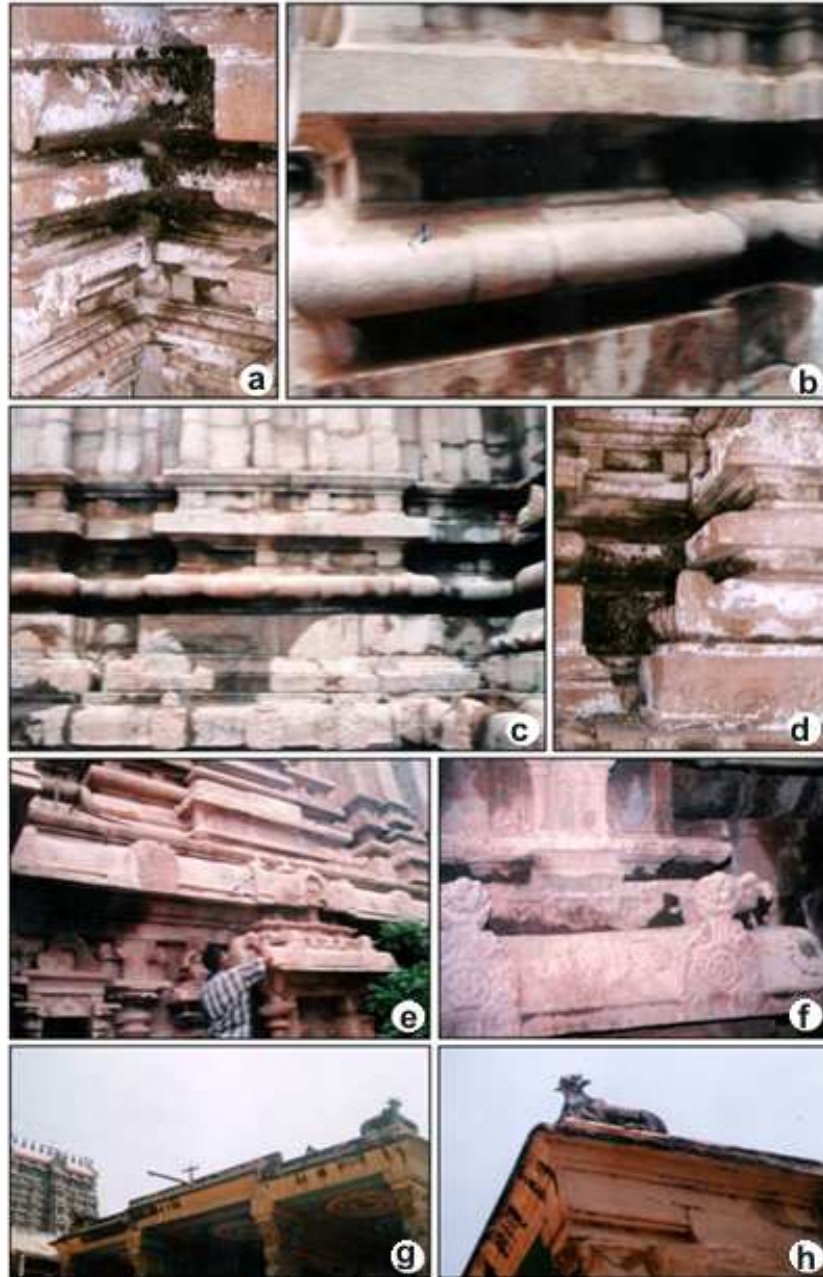
In MĀ, ākshi cuntarēswarar temple algae are found on the walls, joints of mouldings, and structures on which water stagnation is observed. They are abundant in stone crevices and in between the space of weathering rocks (Plate 6; Fig. a to h).

Plate 6 MĀ, ākshi cuntarēswarar temple, Madurai

a&b Basement of a gopura; c. Basement and wall of a gopura; d. Basement of a gopura;
e&f Pedestal and wall segments of gopura; g&h A maṣṣapa entablature

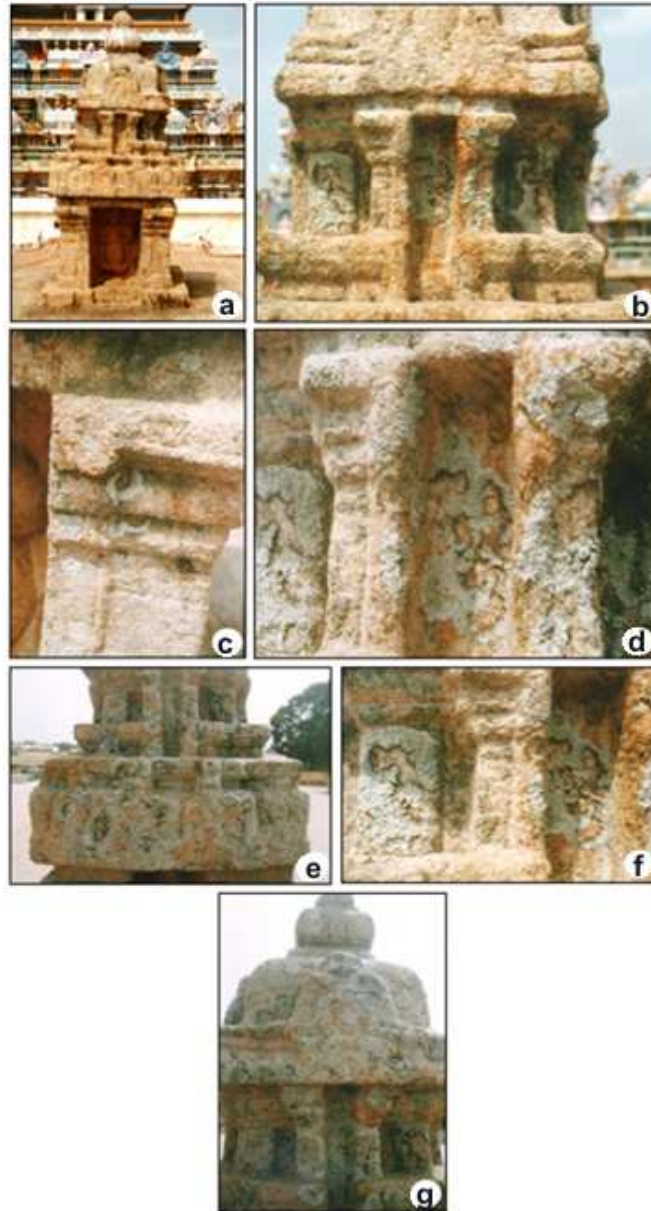
Plate 7 Araḍkanātar temple, Srirangam
a - g. A pillar top segment infected by lichens

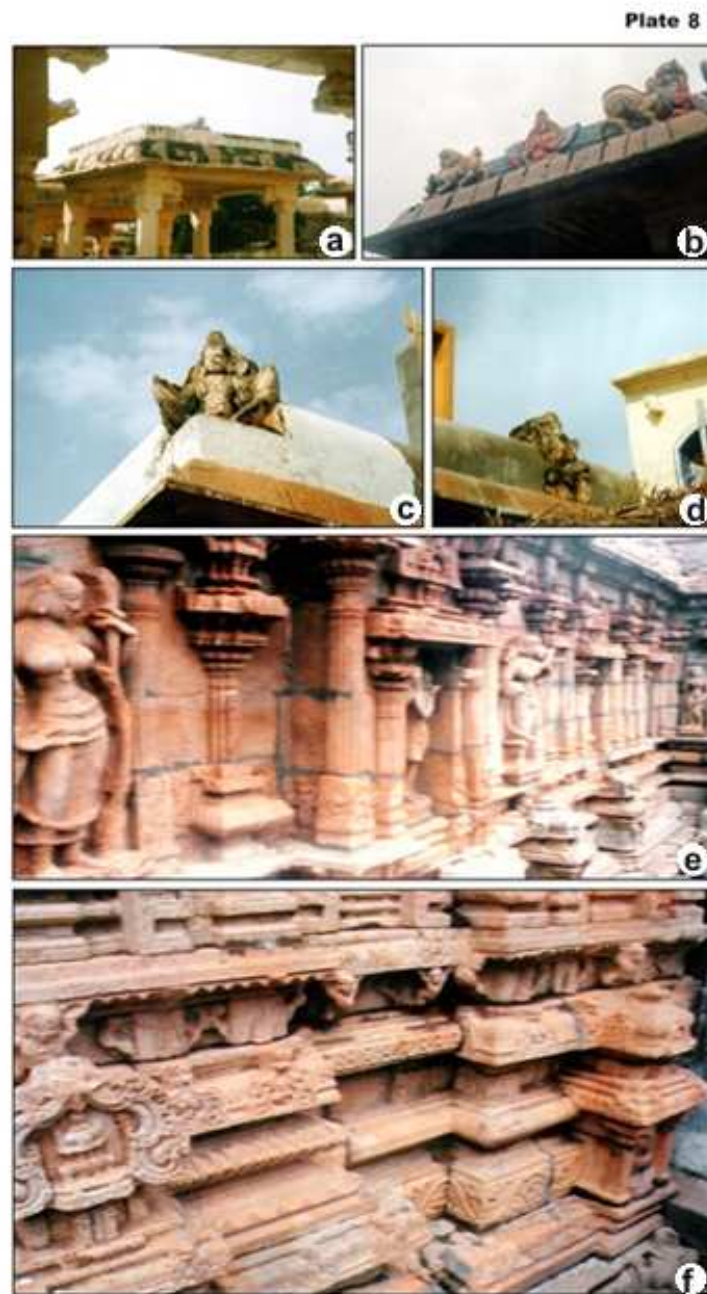
In Araḍkanātar temple, algae are found in the walls, joints of mouldings and walls below basement segments, crevices of stones of various structures (Plate 8; Fig. a to f). Especially, the algae could be noticed in the *maḍḍapa* roof on the lower side at the joints of pillars and water leakage areas. At the base of pillars, in joints of segments, *Oscillatoria* and other filamentous green algae are present. Unicellular forms are present in the stagnant water around sculptural parts in the pedestals of pillars. On the walls, algae grow in between the broken or weathered stones, in the gap of weathered rocks exfoliated. In addition to climatic conditions, growth of dense cluster of algae adds to the weathering of stone sculptures.

Plate 8 Araḍkanātar temple, Srirangam

a. A four pillared maḍḍapa – entablature with organisms; **b.** Entablature of a maḍḍapa with organisms; **c & d** A stucco sculpture infected by organisms; **e.** Venugopalan shrine basement and wall components; **f.** Venugopalan shrine basement segments

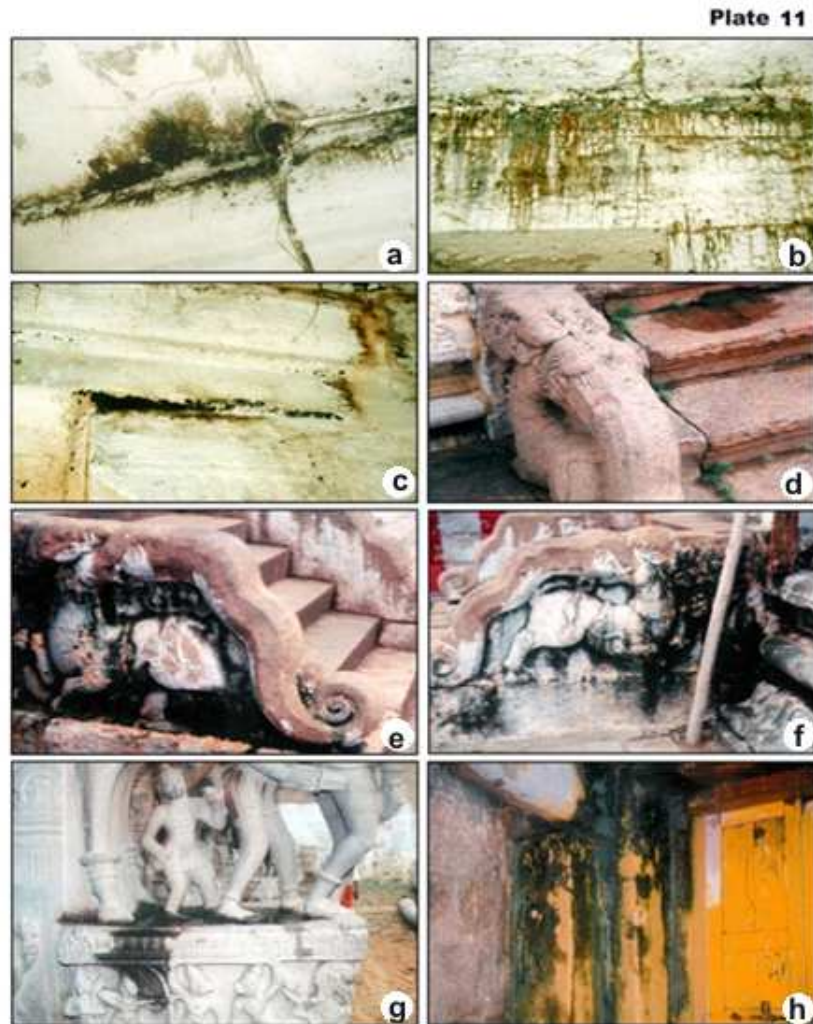
Plate 11 Araḍkanātar temple, Srirangam

a - c. A Maḍḍapa roof with organisms; **d - f.** A shrine yali staircase; **g.** A pillar sculptures after the rain; **h.** A shrine wall with organisms

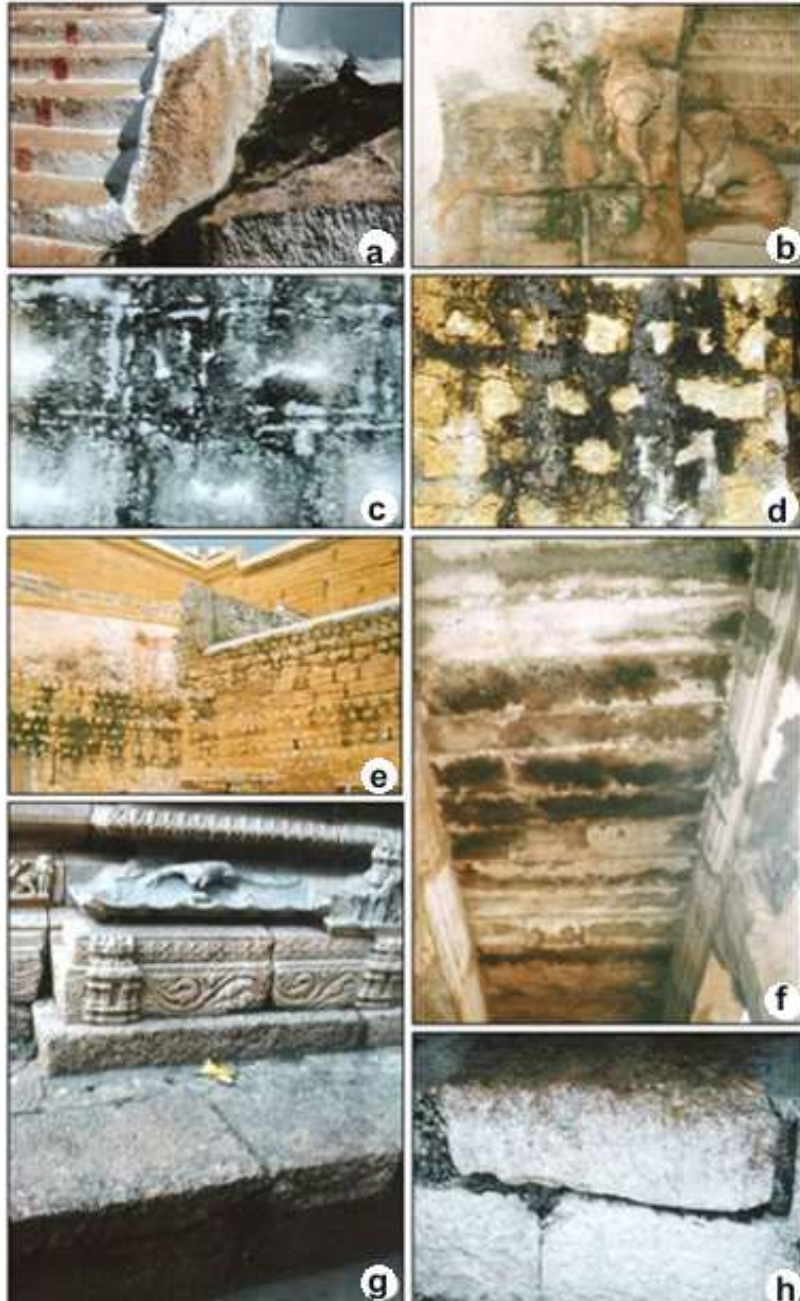
Plate 13 Artanārāswarar temple, Thiruchengodu

a. Running water near a staircase; **b.** A pillar carbel base; **c.** A white washed shrine wall with organisms; **d & e.** Compound wall with organisms; **f.** Roof of a corridor; **g.** A shrine basement; **h.** A pedestal crevice
